Supplementary Note

Studies on rejuvenation of River Godavari and integrated action plan for improvement of Environmental status for Nasik region, Maharashtra (PIL 176 of 2012)

Specific Observations and Recommendations for immediate action to be taken towards cleaning of River Godavari

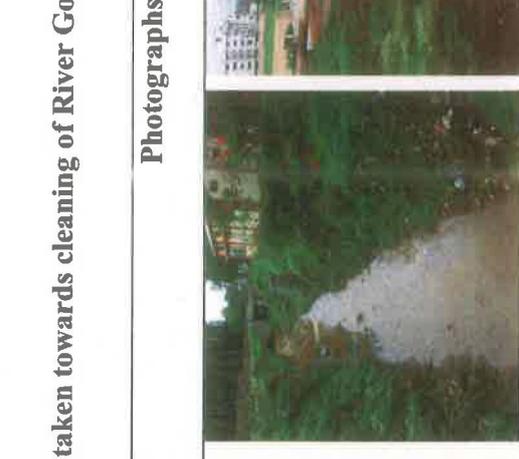
Sr. No.	Observations at Hot Spots	Recommendations	Photographs
1.	<p>Satpur Industrial Area</p> <ul style="list-style-type: none"> Industrial effluent was meeting the nallas which are meant to carry sewage water Through such small nallas, Industrial effluent go into the Chikhali nalla which meet Godavari river upstream of Someshwar waterfall Residential area is adjacent to industrial zone 	<ul style="list-style-type: none"> The disposal practices adopted contribute toxic industrial pollutants either through nallas or through land application. The effluent disposal practices within MIDC area should be strictly monitored by MPCB. There is need to create an intercept point along the nalla which carries industrial effluent so that it can be either lifted and treated or treated at the site.

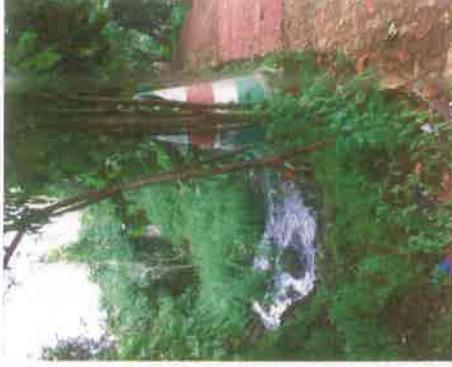
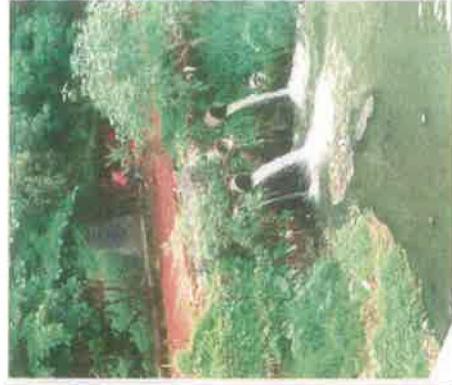
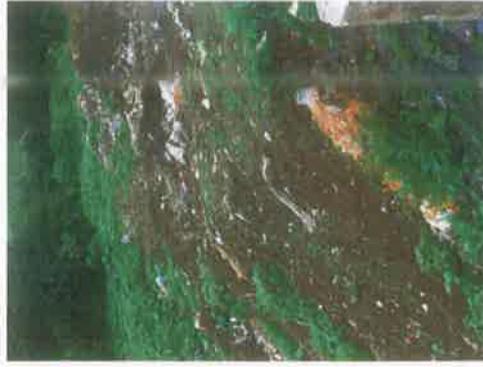
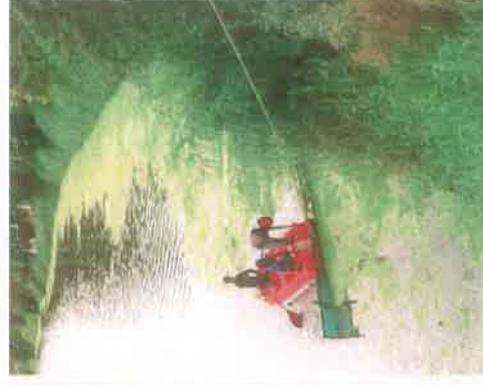
Chopda Lawns

- Sewage water containing backwash of Barabangla Water Treatment Plant entering the river through nalla near the bridge
- Construction and solid waste dumped near Chopda bridge by private agencies
- Removal of water hyacinth was being carried out but the plants were being temporarily moved near the bank which may float back in the river.

- The nalla should be connected to the intercepting sewer line constructed along the river bank.
- In highly polluted nallas and tributaries with inputs of domestic waste and marginal flows of fresh water adequate dilution is not occurring. Recent technologies like “Phytorid” or “Floating wetland” can be adopted to minimise entry of pollutants in the river. This treatment can be a polishing step even when wastewater treatment facilities are functional.
- Dumping of Construction and solid waste near Chopda bridge should be restricted as these wastes flow into the river with rain water.
- Removal of water hyacinth should be carried out effectively. The plant should be cut and removed completely out of the river.

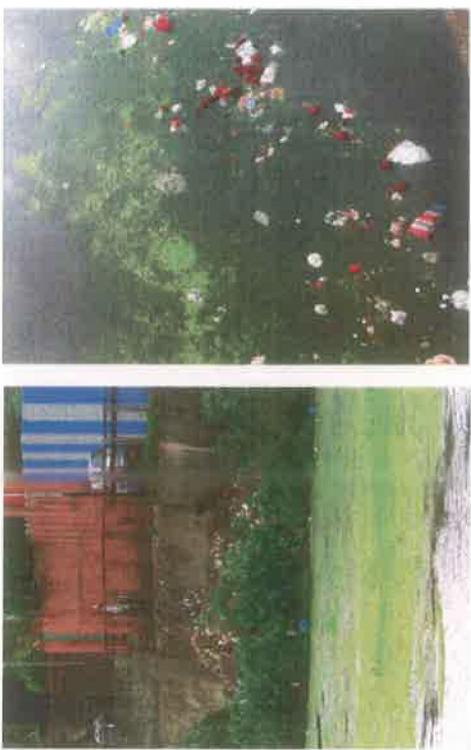
4.	<p>Ramwadi Bridge/ Siddheshwar Temple</p> <ul style="list-style-type: none"> • Extensive growth of water hyacinth • Nirmalya is being thrown from bridge into the river by public • Solid waste dumped along the river bank near the bridge 	<ul style="list-style-type: none"> • Water hyacinth should be removed effectively with weed removal system and taken away from the river banks • Nirmalya kalash should be placed near the bridges • Formation of community groups is recommended for adoption of river stretches along the river banks for prevention of disposal of waste and maintenance of environmental status of the river.

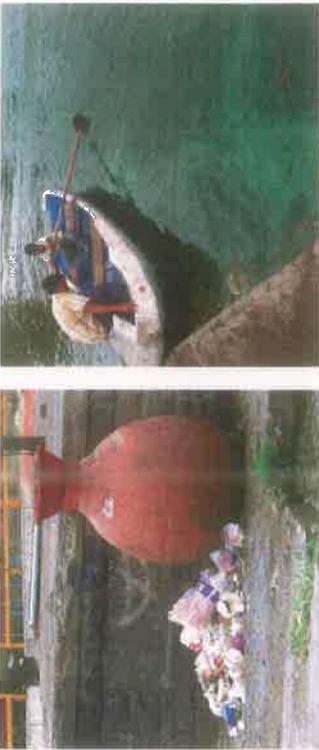
<p>5.</p>	<p>Ramkund/ Gandhi Talav</p> <ul style="list-style-type: none"> • Disposal of Nirmalaya and mass bathing by devotees in Ramkund • Washing of clothes, vessels by public and solid waste accumulation at Ramghat • Vegetable market on the bank of river at Ramghat adding vegetable waste into water • Solid waste thrown out of the Nirmalya kalash • Extensive growth of algal blooms in Gandhi Talav 	<ul style="list-style-type: none"> • Police should strictly restrict disposal of Nirmalaya, Washing of clothes, solid waste disposal in Ramkund and adjacent river stretches • Accumulated solid waste should be removed • In Gandhi Talav, activities which exposes one's body to the water like swimming, drinking, washing vessels or clothes should be restricted as the algal blooms may be toxic. The water should not be stagnant. • Algal blooms should be removed by mechanical means. • Awareness campaign should be further strengthened and its effective implementation should be monitored. The awareness programme budget must include a set of workers/volunteers to dissuade people from polluting and damaging activities.

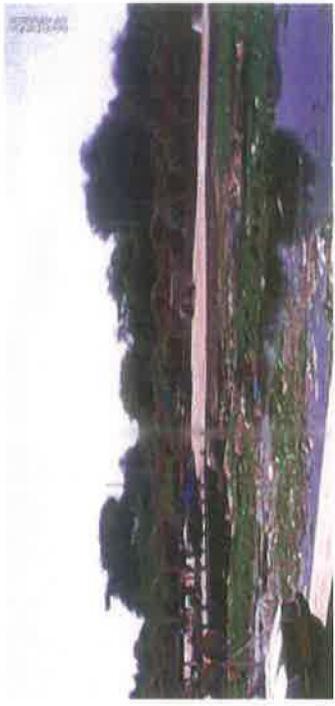
<p>6.</p>	<p>Talkuteshwar Bridge</p> <ul style="list-style-type: none"> • Solid waste disposal and accumulation near the bridge • Excessive vegetation in the river bed due to stagnation of water 	<ul style="list-style-type: none"> • Accumulated solid waste and vegetation should be removed • Normal ecological flow of water should be maintained which can be delineated through detailed study.

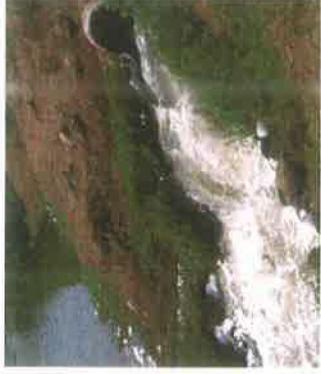
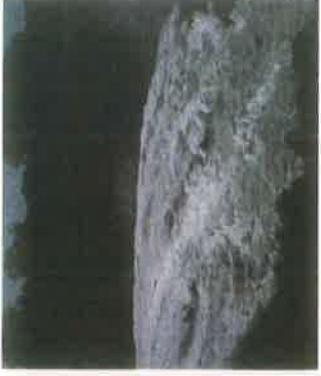
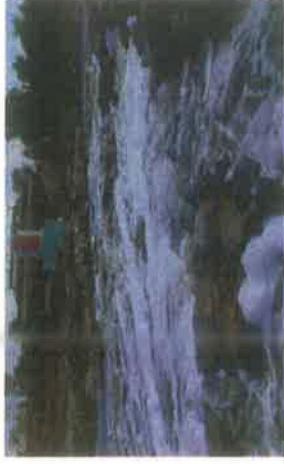
Tapovan and Dasak

- Treated sewage water from STP with excessive foam released into the river

Needs further study pertaining to cause of foam formation.
